INDOOR AIR QUALITY ASSESSMENT

**Morris Elementary School
129 West Street
Lenox, Massachusetts**

Prepared by:
Massachusetts Department of Public Health
Bureau of Environmental Health Assessment
June, 2002

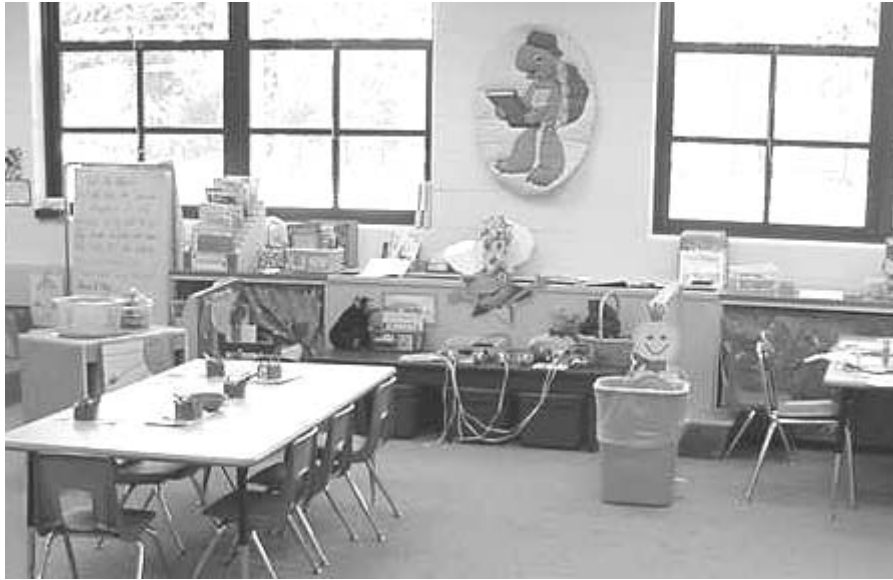
Picture 1

Fresh air in classrooms is supplied by a unit ventilator (univent) system (see Picture 1). Univents draw air from outdoors through a fresh air intake located on the exterior walls of the building and return air through an air intake located at the base of each unit. The mixture of fresh and return air is drawn through a filter and a heating/cooling coil, and is then provided to classrooms from the univent by motorized fans through fresh air diffusers located at the top of the unit (see [Figure 1](#)). Univents were functioning in all but two classrooms examined. Univents were found blocked with chairs, desks, books and other obstructions (see Tables). In order for univents to function as designed, the fresh air diffuser and return vents must be clear of obstacles. Exhaust ventilation in classrooms is provided by a mechanical exhaust system. Exhaust vents were operating in all assessed classrooms.

Univent in Classroom, Note Blockage with Materials

5. Remove potentially flammable materials from kiln room.
6. Remove all blockages from univents and exhaust vents to ensure adequate airflow.
7. Once both the fresh air supply and the exhaust ventilation are functioning properly, the system should be balanced by an HVAC engineer.

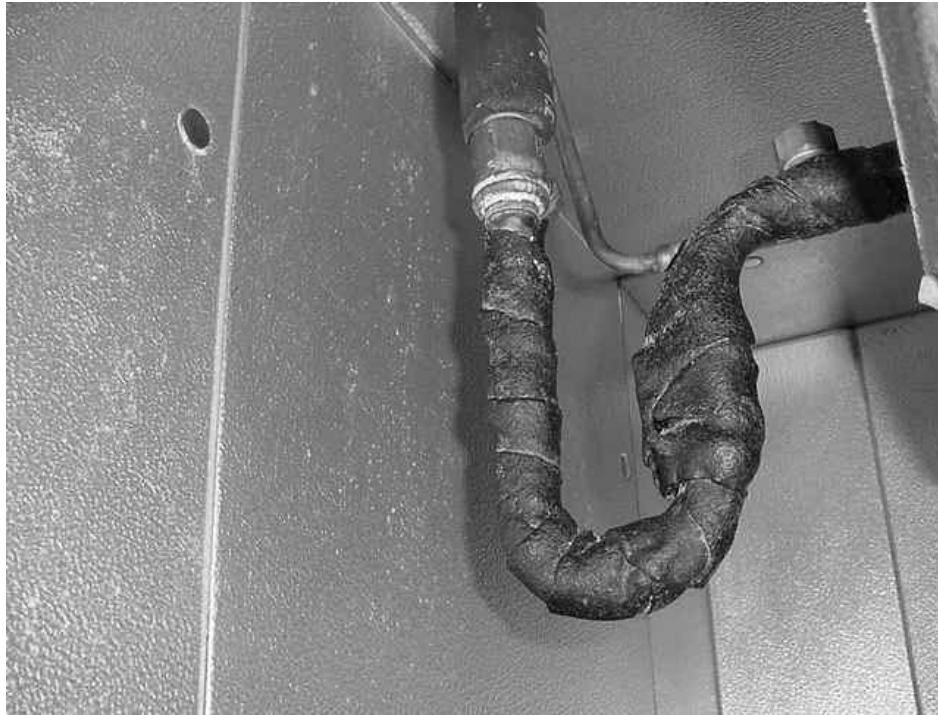
Picture 2

Mr. Steurwald reported that a pipe within a walk-in refrigerator serves as a source of chronic water generation (see Picture 2). When warm, moist air passes over a surface that is colder than the air, water condensation can collect on the cold surface. Over time, water droplets can form, which can then drip from a suspended surface. For this reason, pipes in refrigerated spaces are insulated. The insulation on this pipe is incomplete. Insulation should be continuous over the entire course of the pipe, with all seams and ends sealed to prevent air contact with the pipe.

Pipe Within Walk-In Refrigerator

19. Totally insulate the pipe in the refrigerator with insulation with a sufficient R-rating to prevent condensation.
20. Relocate student drop off area or have busses shut off engines after five minutes as required by Massachusetts General Laws 90:16A.

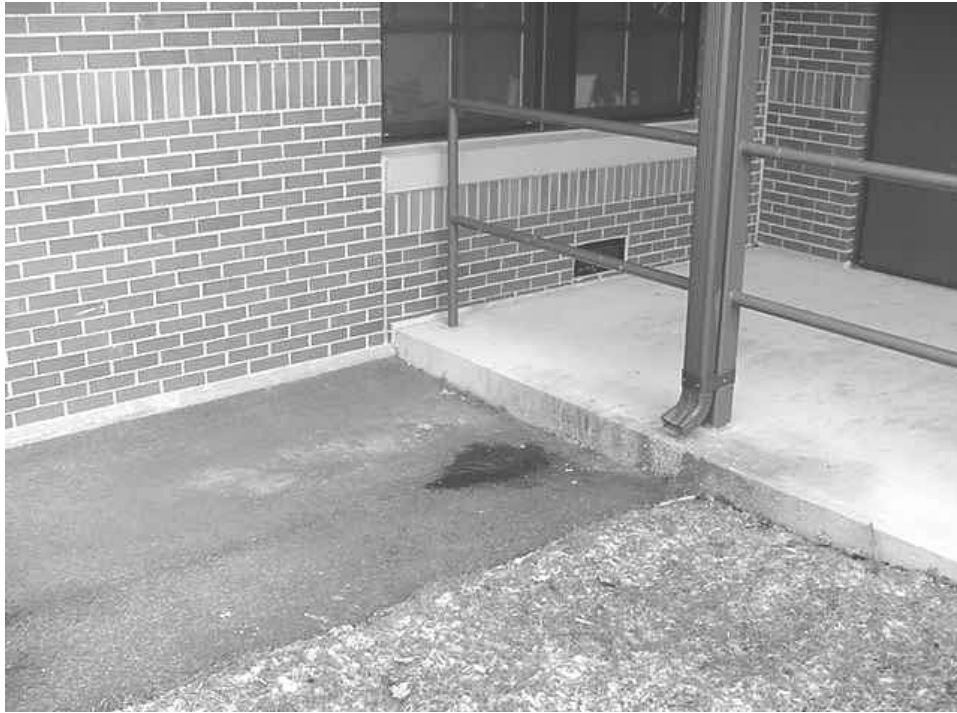
Picture 4

The conditions within room 129 were examined to determine possible sources of pollutants that may be entering this area. Of note is the location of this room. It is the only room located on a cement slab that was installed during the 1996 renovation. The junction between the exterior wall and slab is unsealed (see Picture 3). A board exists within this seam, which may have been used when the slab was poured. A roof was installed over the slab. A downspout from the roof empties onto a tarmac building apron that appears to be sloped toward the slab. In addition the downspout elbow terminates on the slab, which may result in the placement of water on the slab (see Picture 4).

Downspout That Terminates on the Slab, Note the Dirt Accumulation and Wet Spot on the Tarmac, Which May Denote Water Puddling

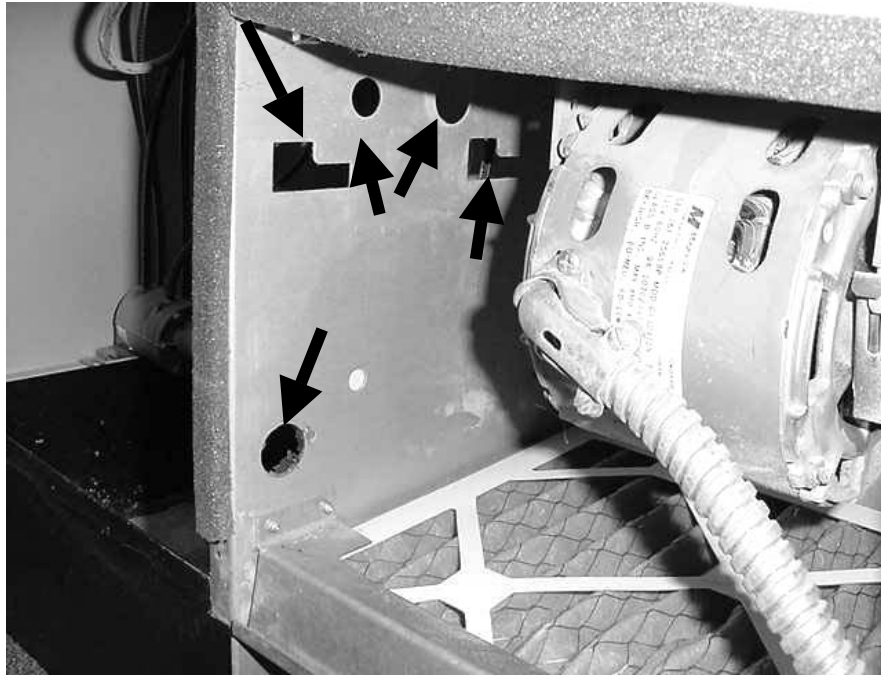
Picture 5

As previously discussed, the interiors of univents in the original building were spot-checked. Walls in which univents are installed have spaces and holes within the casing that open into the wall cavity. Also noted, were spaces around heating pipes that penetrate through the floor. Spaces of this nature can result in the univent drawing air and debris from the wall cavity and distributing these materials to the interior of the building.

Spaces In The Air Handling Cabinet Wall

4. Seal holes inside univents with rigid foil faced sheet material and water based high temperature and fiber reinforced mastic. Temporarily sealing the holes in this manner would prevent both air and moisture penetration into univents.

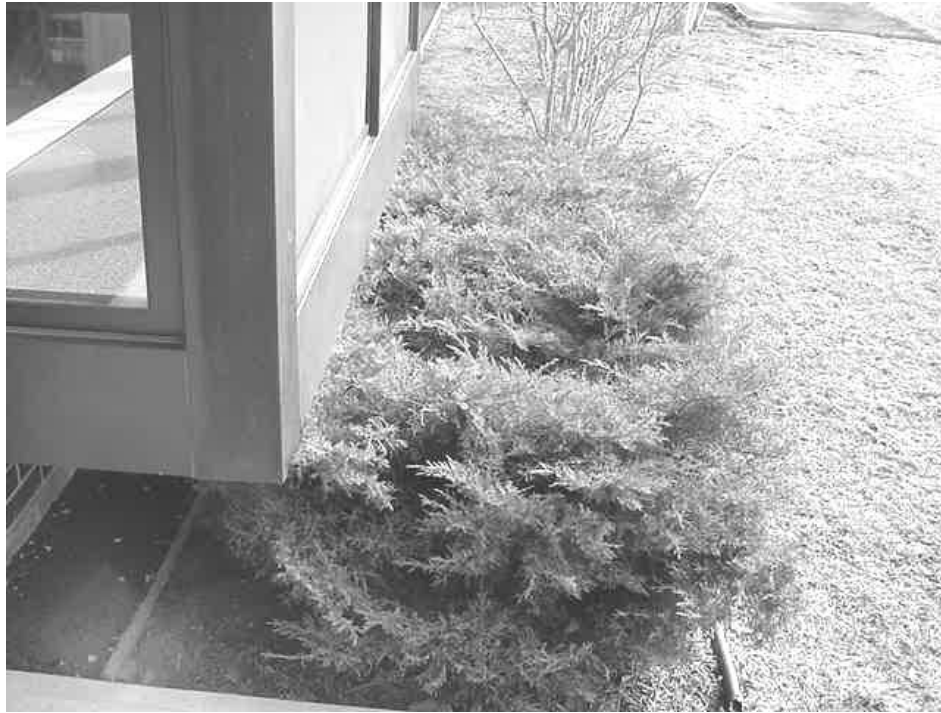
Picture 6

Several other conditions that can potentially affect indoor air quality were also identified. Shrubbery in direct contact with the exterior wall brick was noted in several areas around the building (see Picture 6). Shrubbery can serve as a possible source of water impingement on the exterior curtain wall due to the location of plants and tree branches growing directly against the building. Plants retain water and in some cases can work their way into mortar and brickwork causing cracks and fissures, which may subsequently lead to water penetration and possible mold growth. One classroom also

Shrubbery In Contact With Exterior Wall

11. Remove plants over or in close proximity to univent fresh air diffusers.
12. Reduce/trim or remove plants that are growing against the exterior brick curtain wall.

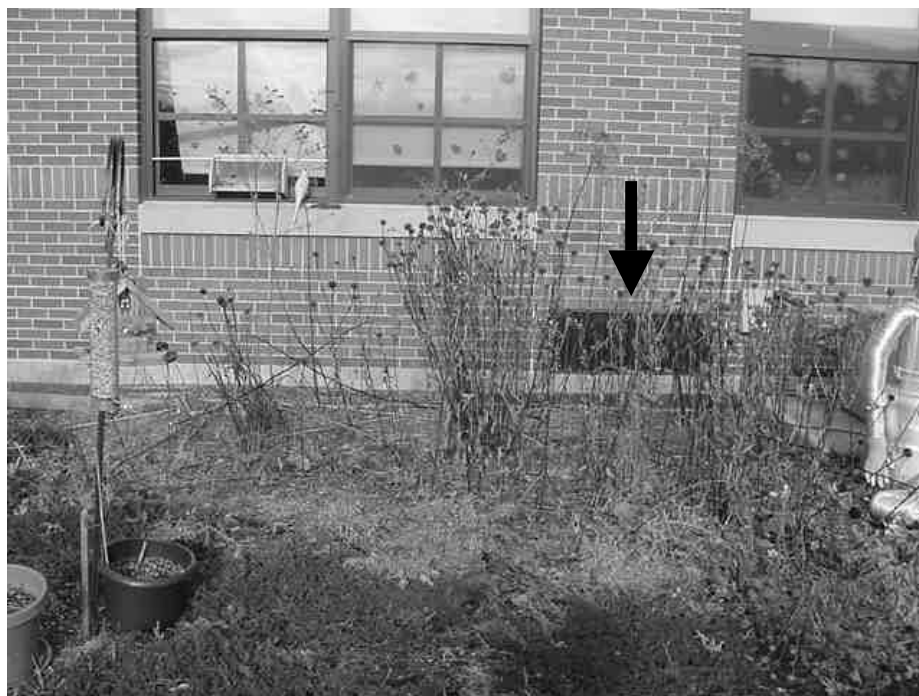
Picture 7

has a garden located outside, near the fresh air intake of the classroom univent (see Picture 7). Plants can be a source of materials that are irritating to the respiratory system.

Garden In Close Proximity to Univent Fresh Air Intake

13. Consider moving gardens away from fresh air intakes.
14. Move the photocopier away from the univent in room 125.

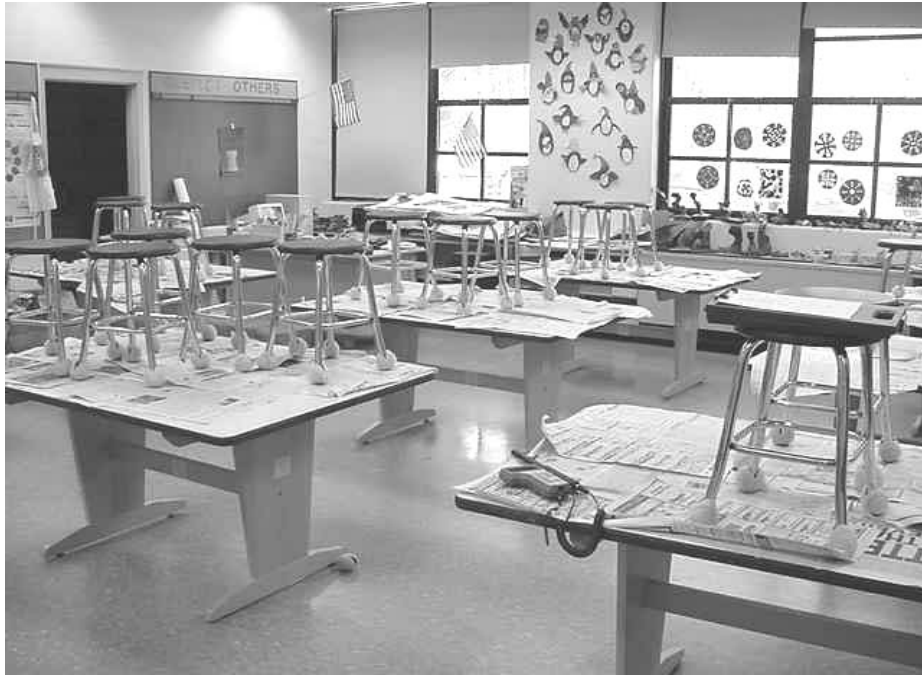
Picture 8

In an effort to reduce noise from sliding chairs, tennis balls are sliced open and placed on chair legs (see Picture 8) in some areas. Tennis balls are made of a number of materials that are a source of respiratory irritants. Constant wearing of tennis balls can produce fibers and off-gas volatile organic compounds (VOCs). Tennis balls are made with a natural rubber latex bladder, which becomes abraded when used as a chair leg pad.

Use of tennis balls in this manner may introduce latex dust into the school environment. In addition, examination disposable gloves containing latex was observed within the building. The use of latex gloves may also introduce allergenic powder into the environment. Some individuals are highly allergic to latex (e.g., spina bifida patients) (SBAA, 2001). It is recommended that the use of materials containing latex be limited in buildings to reduce the likelihood of symptoms in sensitive individuals (NIOSH, 1997). A question and answer sheet concerning latex allergy is attached as Appendix II (NIOSH, 1998).

Tennis Balls On Stool Legs

9. Store food products in airtight containers and cans in sealed plastic bags to prevent the attraction of pests.
10. Discontinue the use of tennis balls on chairs to prevent latex dust generation.
Consider using an alternative to latex gloves.

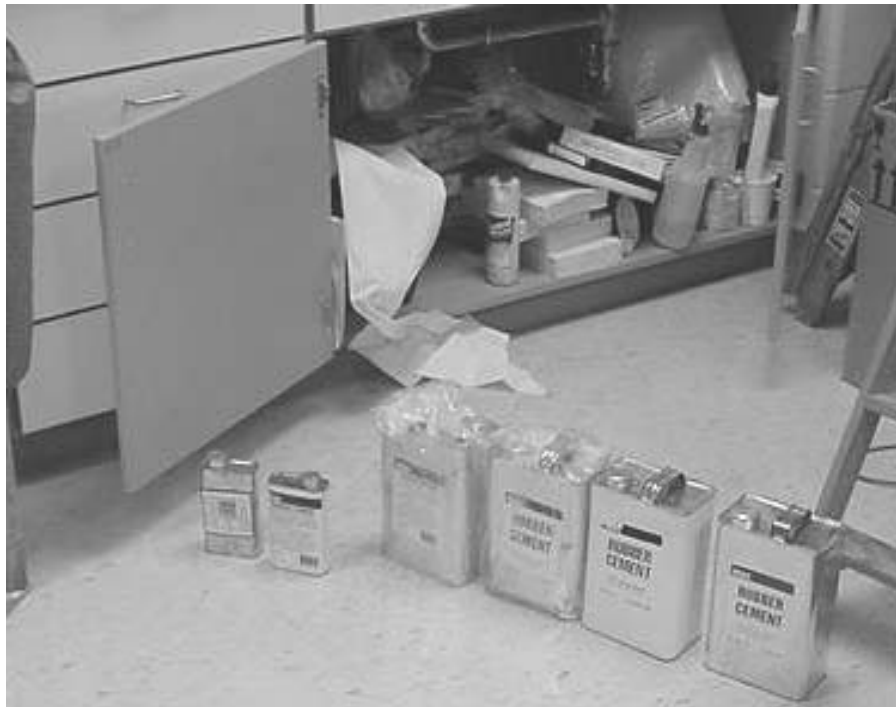
Picture 9

Of note is the use of different VOC containing products in the building. Rubber cement may contain n-hexane, which can be irritating to the eyes, nose and throat; in addition n-hexane is an extremely flammable material. Local exhaust ventilation should be utilized when this material is used. Six containers of rubber cement were found stored in a cabinet within room 124 (see Picture 9). Due to the quantity and flammable nature of rubber cement, these materials should be stored in a flameproof cabinet that meets the standards of the National Fire Prevention Association (NFPA) (NFPA, 1996).

Rubber Cement Containers Extracted From Storage Cabinet in Background

16. Store flammable materials in flameproof cabinets consistent with local and state fire codes.
17. In order to ascertain whether the pipe is cracked, BEHA staff suggested that oil of spearmint be poured into the rooftop vent pipe that services the restrooms. This should be done after school hours. If spearmint odor is detected in the restroom, that would indicate the existence of a cracked pipe.

18. Acquire current Material Safety Data Sheets for all products that are used in the building that contain hazardous materials (e.g., rubber cement), including office supplies, in conformance with the Massachusetts Right-To-Know Law, M.G.L. c. 111F (MGL, 1983).

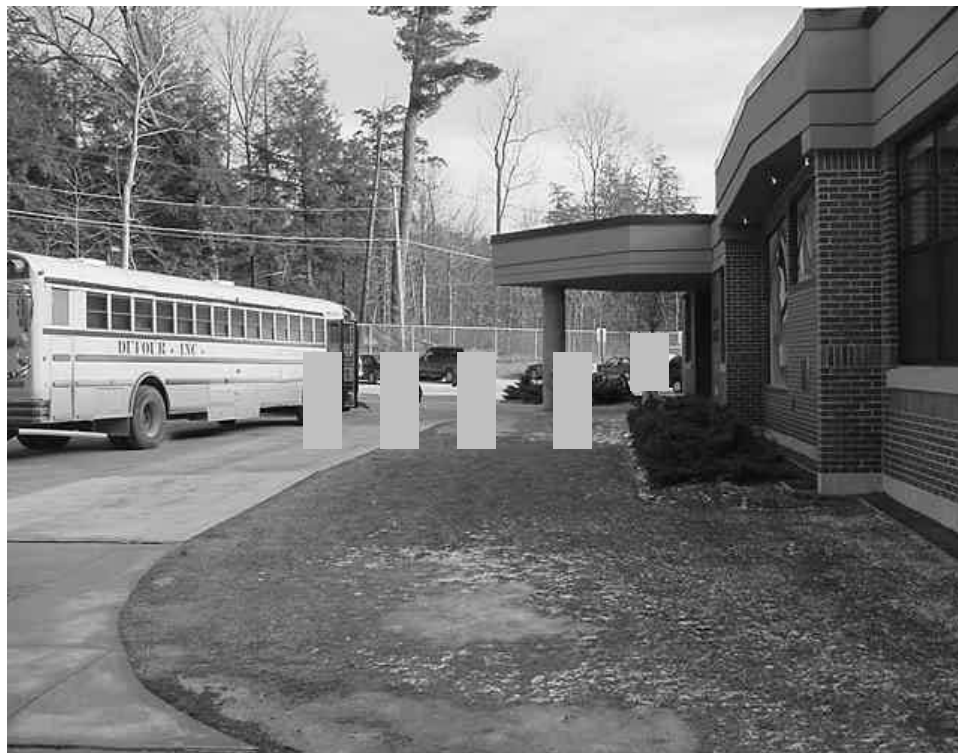
Picture 10

Complaints of bus exhaust odors have been reported within the building. This has been attributed to the idling of busses at the student drop-off area (see Picture 10) and the entrainment of vehicle exhaust into the building via the ventilation system. M.G.L. chapter 90 section 16A prohibits the unnecessary operation of the engine of a motor vehicle for a foreseeable time in excess of five minutes (MGL, 1986).

Busses In Close Proximity to Front of the Building

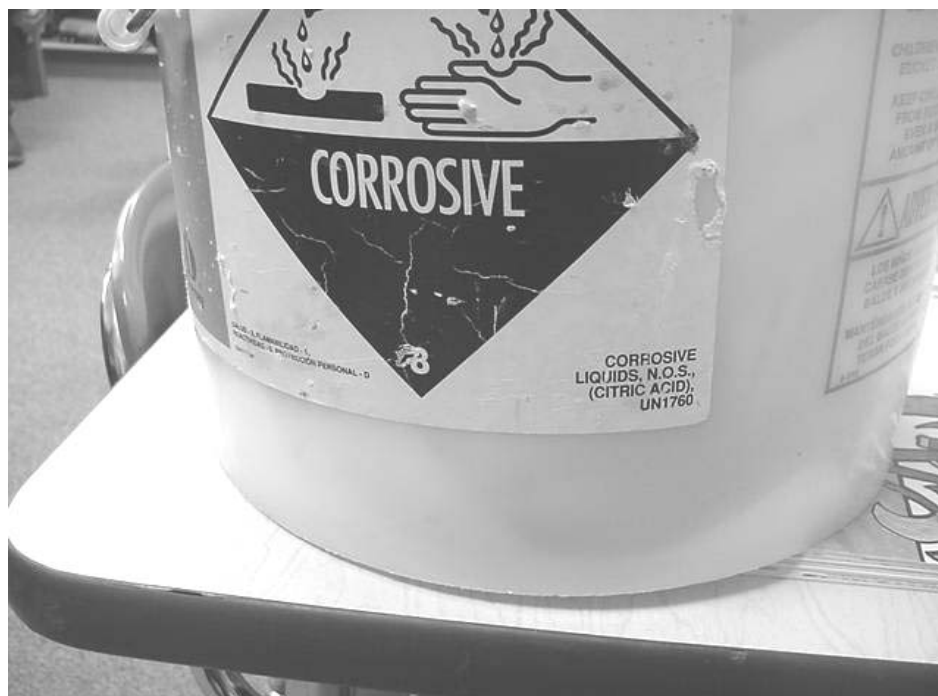
Picture 11

A bucket labeled “corrosive” was noted in room 129, which was used for waste paper (see Picture 11). Containers used to store hazardous materials should not be recycled in this manner, since the container may continue to have a residue of the materials originally stored in the container.

Recycled Container Labeled as Corrosive
